Morphological Dynamics of Braided River Near Bogibeel Bridge, Assam

Abstract

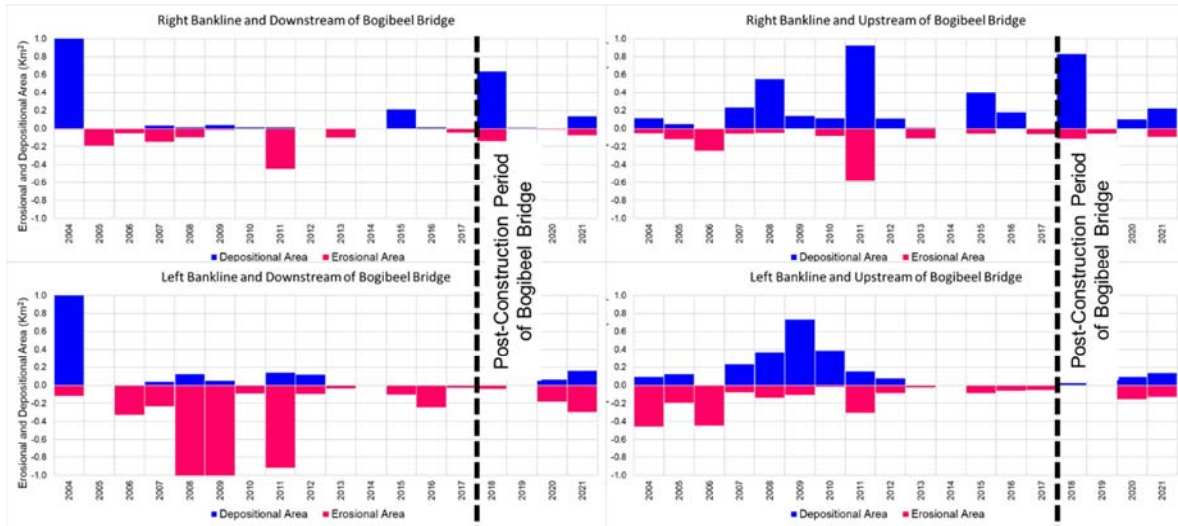
Figure 3. Right-Left and Upstream-Downstream Erosional and Depositional Area Graph.

Overall deposition of the Brahmaputra river reach (within 13 Km) nearby Bogibeel bridge from 2004 to 2021 exceeds overall erosion. The depositional areas on right bankline and left bankline is 6.36 Km², and 5.30 Km² respectively, while erosional areas on right bankline and left bankline is 3.02 Km², and 7.68 Km² respectively. In comparison to upstream of Bogibeel bridge, downstream is more active for erosional process. The average depositional area from 2004 to 2021 (18 years) on right bankline and left bankline is 0.35 Km², and 0.29 Km² respectively, while average erosional area from 2004 to 2021 (18 years) on right bankline and left bankline is 0.17 Km², and 0.43 Km² respectively. From these statistics it is clear that left bankline is more active then the right bankline. Referring to Figure 3, the erosion and deposition pattern of Brahmaputra river reach nearby Bogibeel bridge is showing a decreasing trend, which corresponds to the good river training work and flood management in that area over the last few years.

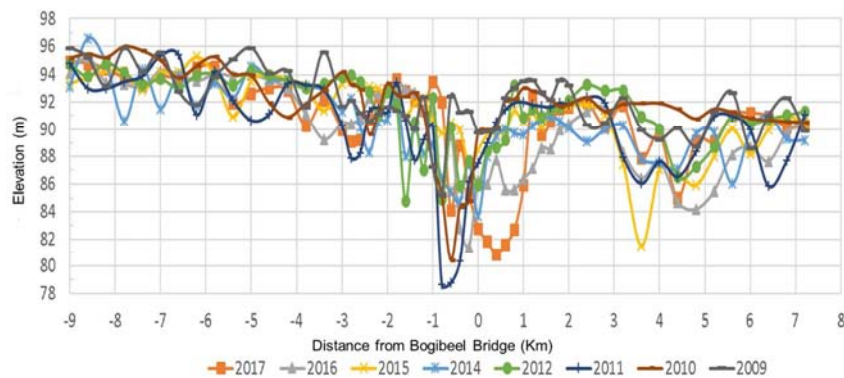
Figure 4. Thalweg Profiles from 2009 to 2017.

The thalweg is the line connecting the deepest bed levels of successive cross-sections of a river. The deepest bed elevations in all the available cross sections of a year were plotted to understand the bed elevation trend between the years. In wide multi-channel rivers like Brahmaputra, these deepest points can switch from one channel to another from one transect to another within a year, and between two successive years. Therefore, the changes in the thalweg profile do not give us a definite value of rising or fall in a channel, but an average representation of changes in the bed of the channel. The thalweg profiles from 2009 to 2017 have been generated by using River Bathymetry Toolkit (RBT) and shown in Figure 4. The changes in the bed profiles for the period 2009 to 2017 are shown in Figure 5.

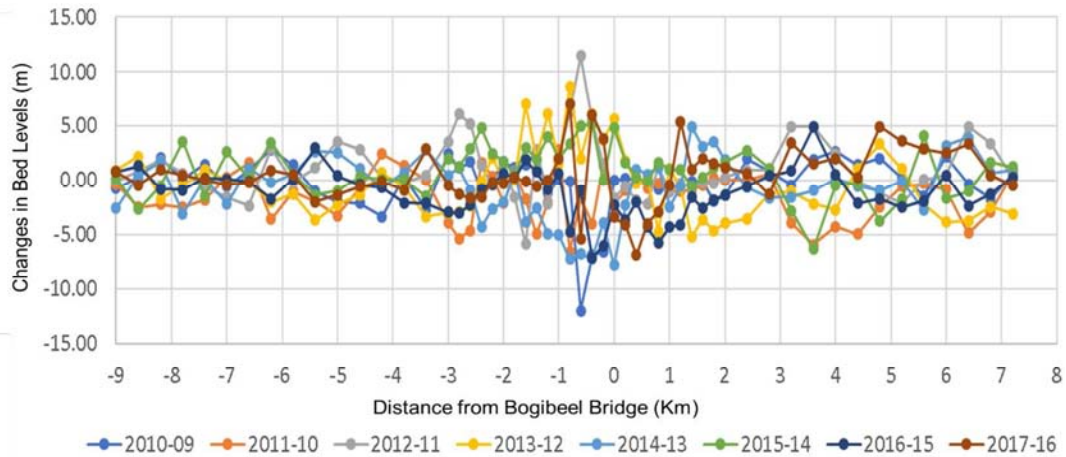
Figure 5. Changes in the Deepest Bed Levels in Consecutive Years.

The analysis of change in the riverbed levels gives the following results: (i) the river is highly dynamic in the entire reach, (ii) the average change in the riverbed level is found to be -0.20 m (fall of 0.20 m), (iii) maximum fall in the bed level was found to be 1.15 m from the year 2010 to 2011, (iv) standard difference was found to be of 2.75 m, (v) the major bed level changes were observed up to 1.6 Km upstream of the bridge, and (vi) maximum rise (11.54 m) and maximum fall (11.99 m), both were observed 600 m upstream of the barrage.

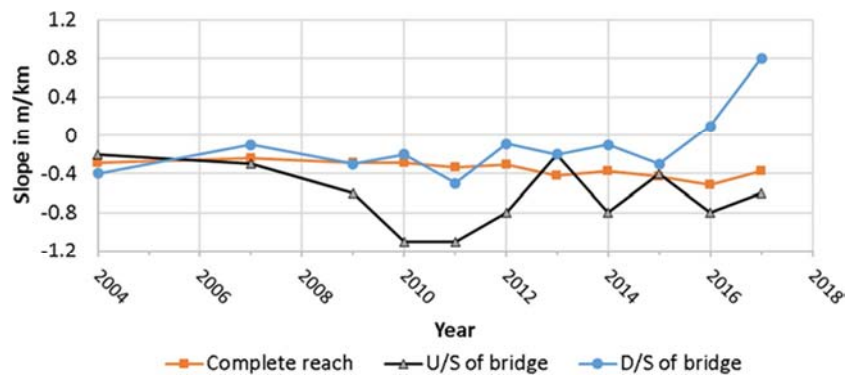
Figure 6. Trend of Riverbed Slope in Various Stretches.

The slope of the deepest channel of the study reach of the river is also calculated. The values of the slopes are given in Table 5. The average slope of Brahmaputra River in this 13 Km reach is found to be nearly 0.35 m / Km (Figure 6). In the trend analysis of the riverbed slope, the results reveal that there is a fall in the slope of the overall channel at a rate of 0.01 m / Km per year, i.e. the slopes are getting steeper. The trend in the riverbed slopes is shown in Figure 7.

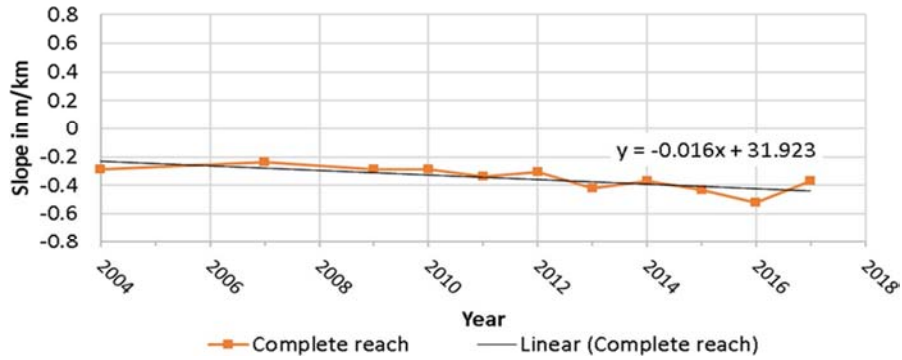
Figure 7. Trend Line Fit for Bed Slopes of Complete Reach.

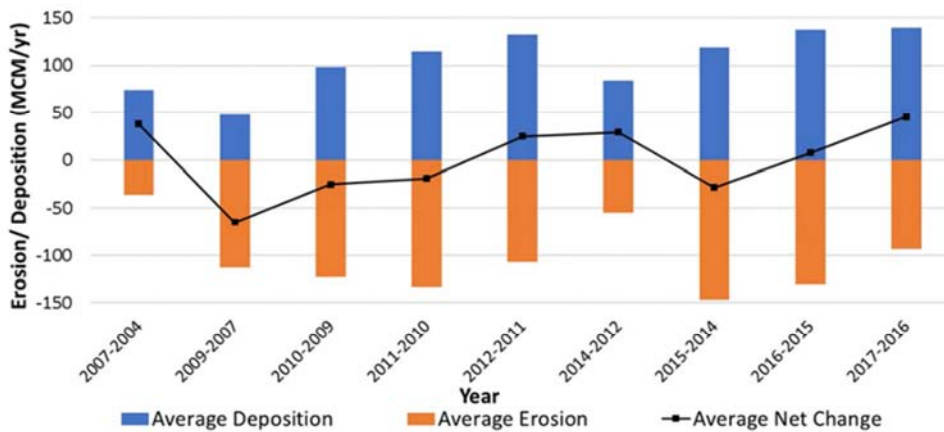
Figure 10. Erosion and Deposition along the Entire Study Reach from Cubature Study.

The spatial distribution of erosion-deposition or bed level changes are mapped and shown in Figure 10. The position of

the rivers for the respective years are also shown for better illustration. In the maps, negative values represent erosion and

positive values represent deposition. Brahmaputra is one of the world's most dynamic river. Formation of new channels, abandonment of old channels, formation of sandbars is observable in this river system. The results of the cubature study are detailed in Table 6.
