# Morphological Characteristics and Vulnerability Assessment of Alaknanda, Bhagirathi, Mandakini and Kali Rivers, Uttarakhand (India)

Kuldeep Pareta<sup>1, \*</sup>, Flemming Jakobsen<sup>1</sup>, Madhu Joshi<sup>2</sup>

<sup>1</sup>DHI (India) Water & Environment Pvt Ltd, New Delhi, India

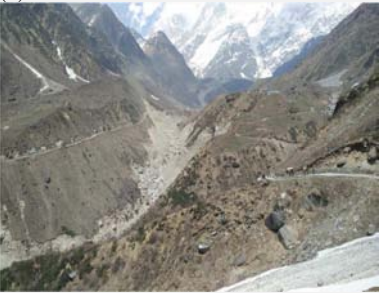
Vulnerable Reaches	Brief Description
(1) Kedarnath

The main problem at this location is excessive toe erosion on both banks of Mandakini and Saraswati, shooting boulders/stones from the north of temple. The famous Kedarnath Temple, human lives, live stocks and properties are at high risk. The local administration has provided 3-tier Protection work viz. Gabion wall, wired mesh & RCC counterfort wall towards the north of the town. Also, the left bank of Saraswati river has been provided with gabion walls. The bank of Mandakini river towards the southern part of town is eroded up to high relief, thereby rendering the strategic assets vulnerable. It is evident from the photographs that stretch downstream of Kedarnath up to Rambara is highly susceptible to landslides.

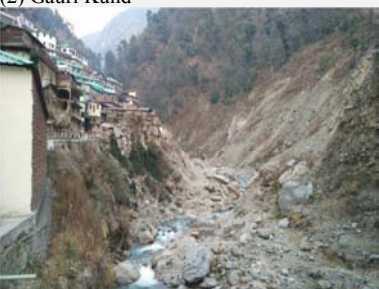
(2) Gauri Kund

It was one of the worst affected areas during the 2013 flood. At this location, river flows through narrow channel; it enters on a slight bend and flows through a generally straight channel along the town. There is extensive erosion and deposition along both banks with huge boulders lying within the river channel, thereby constricting its width (Photograph). The slope is vertical along right bank with loose soil-gravel matrix and rocky exposures occur intermittently. The left bank is steep with extremely loose-soil gravel matrix along the town.

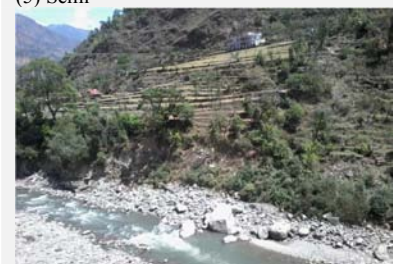
(5) Semi

<p>Semi is a small village located at higher elevation on the right bank of Mandakini. Though the village is at higher elevation, it has suffered severe damage due to Mandakini. River is generally flowing in a straight profile.</p>

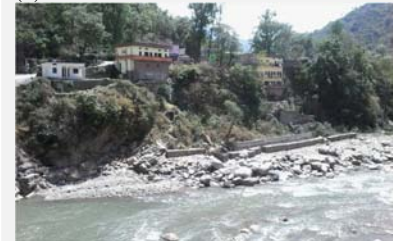
(7) Bansbada

<p>The village is situated on the left bank of river. Mandakini enters the village on a bend &amp; flows under the bridge obliquely. Vertical slopes on both banks can be seen made of loose soil-gravel 38 River Morphology Report with rocks exposed intermittently. Left bank is important as residential &amp; commercial establishments are located on it whereas right bank only has a road. River section at this village is moderately wide. The main problem at this location is also the bank erosion (Photograph).</p>

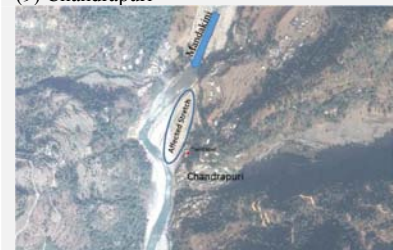
(9) Chandrapuri

<p>Chandrapuri town is mainly situated on left of river while mostly agriculture lands are on right. The river while entering the town turns left. A small nala joins the river further downstream through the heart of the town. River section is moderately wide with heavy debris on both banks. The main problem at this location is the extensive toe erosion of both banks as the banks.</p>

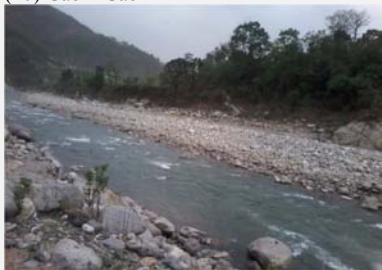
Vulnerable Reaches	Brief Description
(10) Gabni Gaon

The residential and commercial establishments in the Gabni Gaon are mostly situated on the left bank of the river. The river is flowing almost straight at this location with relatively wider section. Debris deposition can be observed on both the banks of the river. The main problem at this location is the extensive toe erosion of both banks as the banks are mainly composed of loose sand and gravel materials (Photograph).

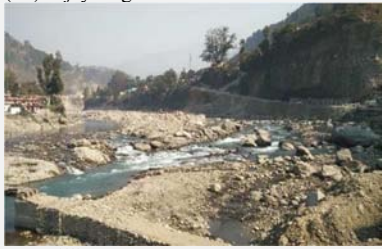
(13) Vijay Nagar

The Vijay Nagar town is located on both banks of Mandakini, however, mostly populated on the left bank. The river flows along the town with minor left turn. The river width is moderate all along the town. The main problem at this location is the extensive toe erosion of both banks as the banks are mainly composed of loose sand and gravel materials.

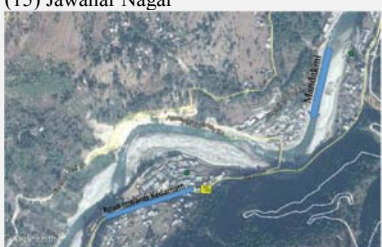
(15) Jawahar Nagar

The entire residential and commercial establishments in the Jawahar Nagar are situated on the curvilinear left bank of river. The river is hugging the right bank in the heart of the town. Just down of the town the river is hitting the road on left bank (Figure). The river section along the town is wide but full of debris and boulders. The main problem at this location is the extensive toe erosion of both banks as the banks are mainly composed of loose sand and gravel materials.

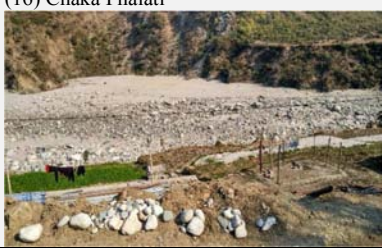
(16) Chaka Phalati

River is flowing almost straight all along the town. Wide spread residential buildings are on the left bank whereas the right bank is mostly agriculture land and few houses at higher level (Photograph). Both banks are visibly eroded. The main problem at this location is the extensive toe erosion of both banks as the banks are mainly composed of loose sand and gravel materials.
