Geotechnical Study of the Dikes on the Left Bank of the Ikopa River in Antananarivo, Madagascar

Abstract

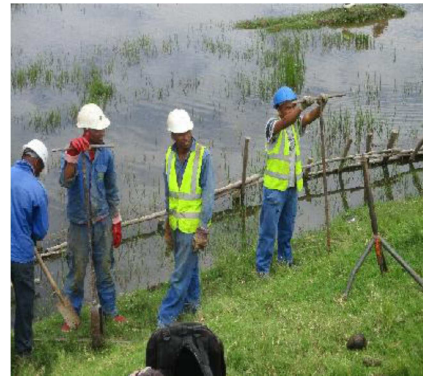
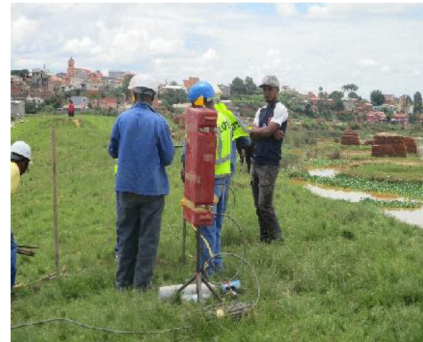
Figure 1. On-site photos.

The hand augering test allows to have first the geological section in depth of a site and to serve as a pre-hole to the pressiometric measurement every meter of depth by a radially dilatable probe under the effect of a liquid pushed by a compressed gas [12].
