Determination of River Bank Erosion Probability: Vulnerability and Risk in Southern Shoreline of Bangladesh

Abstract

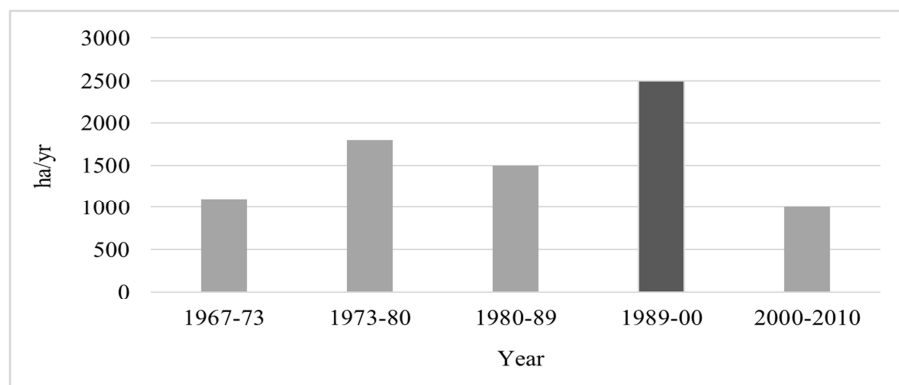
Figure 4. Decadal Erosion Pattern along the Padma River.

Annual average peak discharges have been calculated as 70,000 m³/s, 50,000 m³/s and 90,000 m³/s for the Jamuna, the Ganges and the Padma rivers respectively for the period of

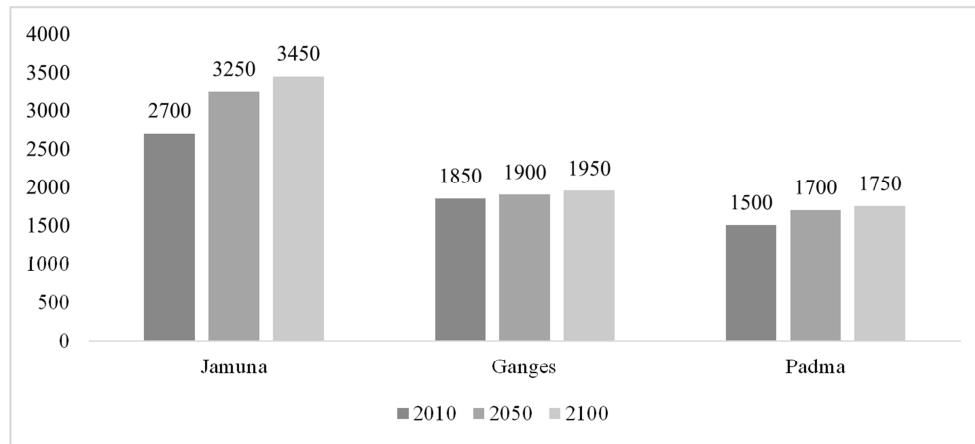
riverbank erosion for 2050 and 2100 are presented in Figure 5 which shows that increase in the average annual erosion rate is higher for the Jamuna and the Padma by 2050 than

that by 2100. On the other hand, the Ganges is in a balance position for 2010-2050 and 2050-2100 durations.

Figure 5. Predicted River Bank Erosion along the Jamuna, Ganges and Padma Rivers [25].

1950-2010. It has been found that an increase in flood discharge by 20% within the year 2100 will increase the annual rate of riverbank erosion substantially. The predicted

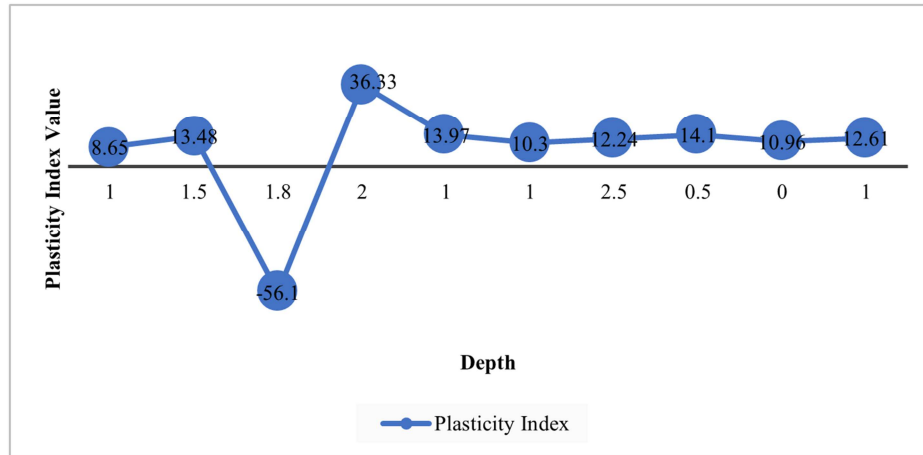
maintaining its form when unstressed. Highest plasticity index (PI) of the River bank at point 4 (sample #4) were found 36.33. At the first point the value of plasticity index 8.65 then respectively 13.48, -56.10, 36.33, 13.97, 10.30, 12.24, 14.10, 10.96, 12.61 (Figure 6) and so on. At the point number three plasticity index showed negative value which strongly describe as a non-plastic soil. The highly plastic

Figure 6. Plasticity Index.

Atterberg limit provides the soil moisture of the study area. The moisture content of the study area is higher; as a result, the soil is loose. That is the causes of earthen River bank failure. Used the % of water content for Y axis and Number of blows were used X axis to calculate the moisture content.

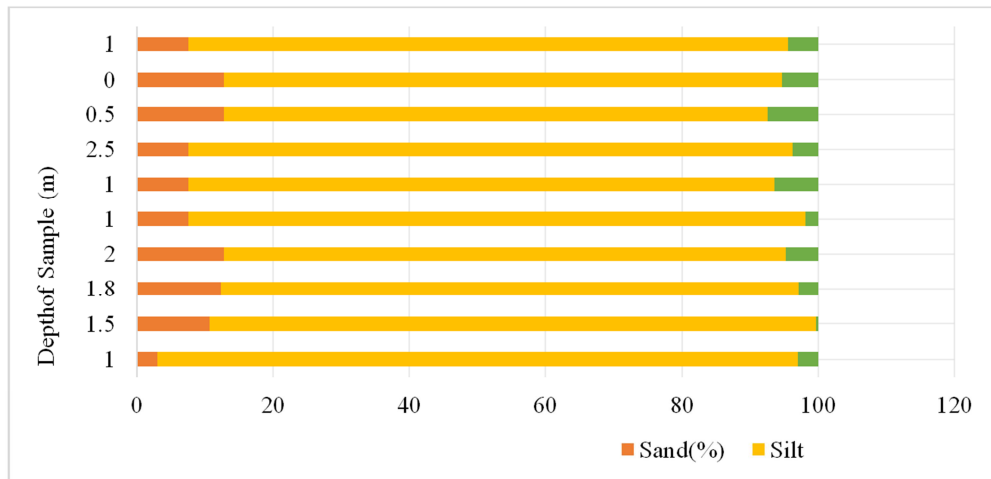
From hydrometer analysis, the fine grain ($<75\mu\text{m}$) content in riverbank soil is found 92.36% (silt=90.506%, clay=1.854%) and the coarse grain (Sand) is 7.64%. The River bank soil was classified as silty soil with lower liquid limit (ML) which contents silt and clay more than 80% on average and other sand respectively. At the point 5 the soil contents highest

amount (90.506%) of silt in contrast to at the point 8 lowest amount (79.82). Besides sample soil content highest amount of sand at the point number 4 which is 12.78 in percentage (Figure 8) compared to lowest amount at first point (3.02) available. All the values from hydrometer testing show high probability of failure as all are more likely sandy soil [32], [33].

Figure 8. Hydrometer Analysis of Soil (<75µm).
